## Repairability of resin-modified glass-ionomer and polyacid-modified resin composite cements

Manal Al-Malik, BDS, MSc, PhD

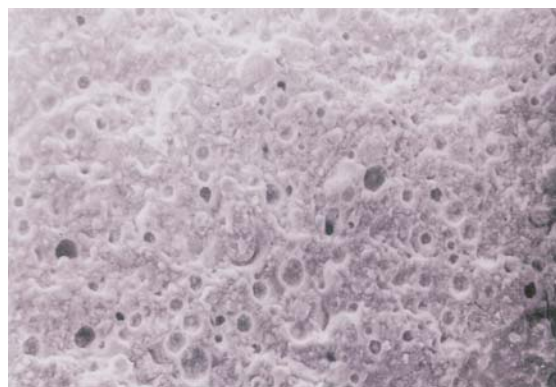
**Fig. 1.** Micrograph of fracture surface of Fuji IX control specimen at 15 KV (500X).

Scanning electron micrographs of the fracture surfaces of examples of the control specimens showed two types of surface. The samples of Fuji IX, Fuji II LC and Vitremer were rough with irregularly shaped glass particles visible on the surface. A large number of spherical holes were also visible, although fewer of these were seen in the Vitremer fracture surfaces than were seen in those for Fuji IX and Fuji II LC. An example of the spherical holes is seen in Figure 1 which showed the fracture surface of a Fuji IX control specimen. In contrast, the surface of the Dyract samples was far smoother and more homogeneous (Figure 2). There were far fewer holes on the surface and those which were present, were irregular in shape.

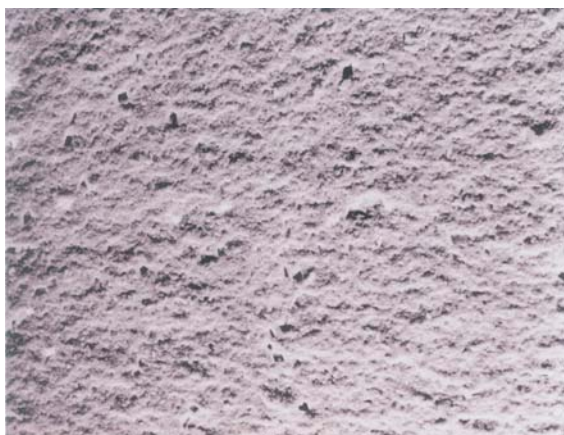
**Fig. 2.** Micrograph of fracture surface of Dyract control specimen at 15 KV (500X).

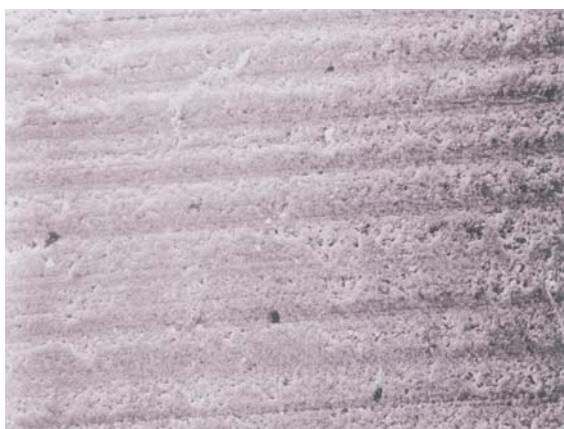
**Fig. 3.** Micrograph of fracture surface of Dyract specimen repaired after 10 minutes at 15 KV (500X).

Visual examination of the fracture surfaces of the repaired specimens showed the occurrence of adhesive, cohesive and mixed adhesive/cohesive failures. Figure 3 showed the fracture surface of a Dyract specimen repaired after 10 minutes. The striations on the surface were caused when the original specimens was sectioned prior to repair.

Such striations were apparent on all the Dyract specimens indicating that they had all failed adhesively.

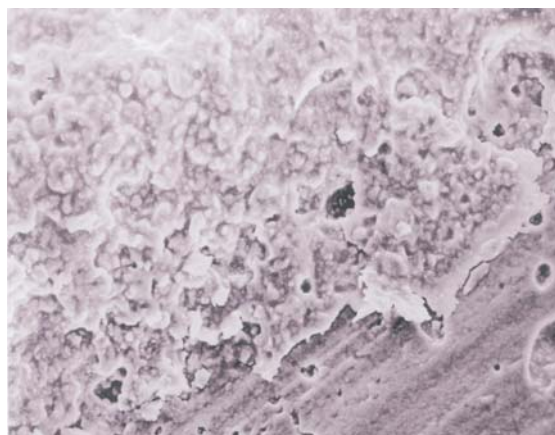
**Fig. 4.** Micrograph of fracture surface of Fuji IX specimen repaired after 10 minutes at 15 KV (500X).

All the Vitremer samples inspected showed cohesive failure, the cut surface was not apparent. Similarly, samples of Fuji II LC and Fuji IX showed cohesive failure for the specimens repaired at 7 days but mixed cohesive/adhesive failure for the specimens repaired at 10 minutes. Figure 4 showed the fracture surface of a specimen of Fuji IX repaired at 10 minutes. The original cut surface was clearly visible in the bottom right hand corner of the micrograph, whereas fracture within the bulk of the material can be seen in the rest of the picture. Any cracks observed in the SEM pictures are due to the desiccation of the specimens required prior to observation under the electron beam.
