## SEALANT BOND STRENGTHS AND ETCHING PATTERN ON ENAMEL DEFECTS

F. Salama, BDS, MS;\* J. Barenie, DDS, MS;† C. Fairhurst, PhD;‡ M. Diab, BDS, MS§

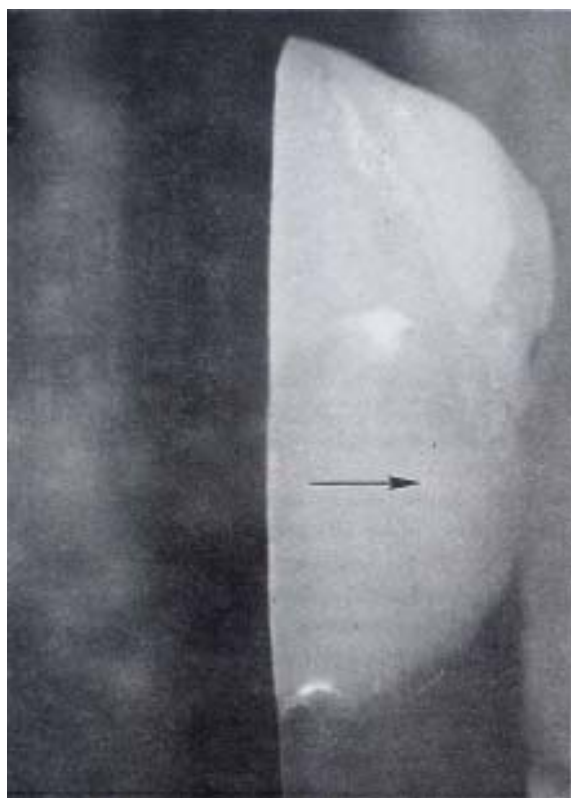
Figure 2. Stereoscopic photomicrograph of sealant (arrow) after application to the facial surface of a sectioned tooth.

Stereoscopic examination (Group IV) of sealant applied to normal smooth surface enamel is shown in Figs. 1 and 2. Sealant formed a semi-circular layer on the smooth buccal surface of both normal and defective enamel. It was evident that this layer is thick in the center and becomes thin as it approaches the periphery. Scanning electron microscopic examination showed close contact of sealant to etched enamel surface with no evidence of damage or separation [Fig. 3].

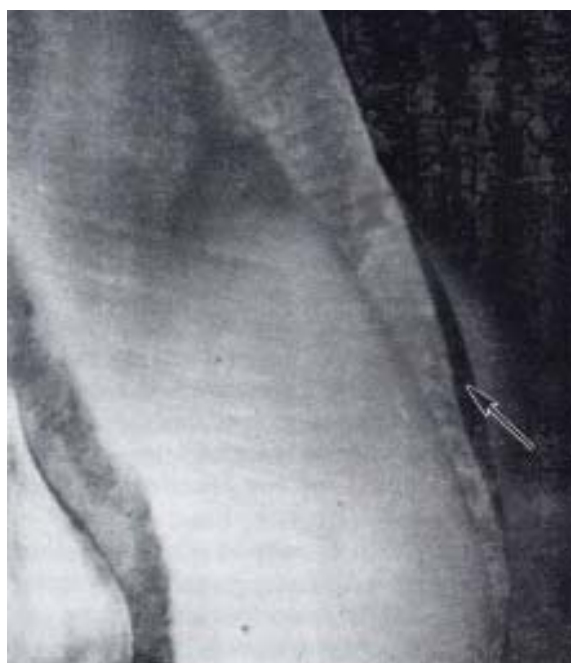
Figure 3. Stereoscopic photomicrograph of a sectioned tooth showing sealant (arrow) on the enamel surface.

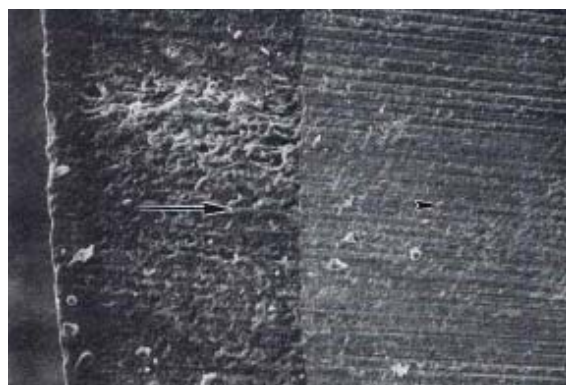
Figure 4. SEM photomicrograph of enamel (arrow) - sealant (arrowhead) interface. (x120)

Stereoscopic and SEM examinations depicted close contact between the resin and etched enamel. Such close contact may reduce microleakage and decrease the incidence of caries recurrence or further decalcification of enamel defects.

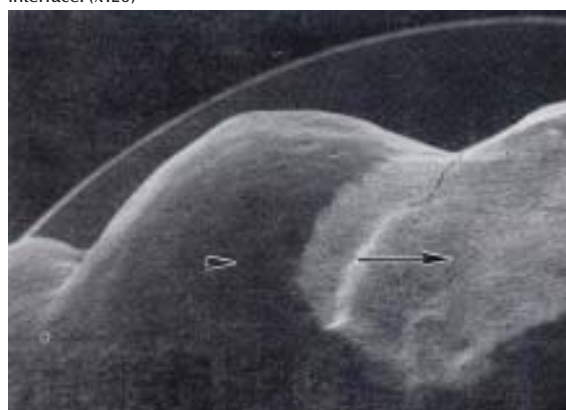
Figure 5. SEM photomicrograph of normal enamel with (arrow) and without (arrowhead) etching. Note the perikymata patterns (asterisk). (x 19)

etched and compared to an adjacent unetched area [Fig. 5]. In group IV, normal and defective enamel surfaces were examined following sealant application and were photographed using a dissection microscope.

Normal smooth surface enamel (Group III) with and without etching is shown in Figure 5. Scanning

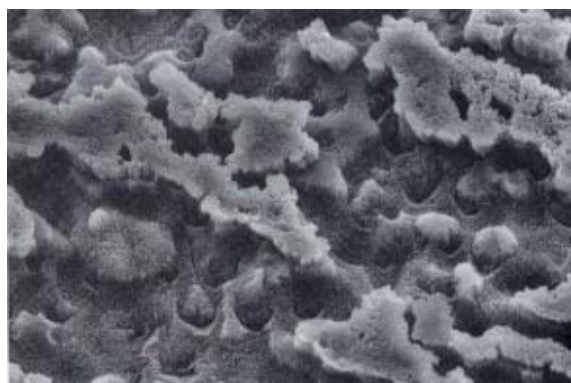
Figure 6. SEM photomicrograph of normal enamel that has been etched for 60 seconds. Note the periphery of prisms (arrow) etched preferentially (type 2). (x3900)

electron microscopic examination of etched normal smooth surface enamel showed the usual etching patterns reported by Silverstone et al.<sup>13</sup> However, type 2 etching pattern in which the periphery of prisms were preferentially etched was more common [Fig. 6]. Scanning electron microscopic examination of etched smooth surface enamel defects, depicted in Fig. 7, showed peculiar surface structure with vague resemblance to the usual etching patterns of normal healthy enamel. In few areas, the etching pattern of these defects tends to appear more like etched dentin surface with some surface debris.

In this study, etching patterns of normal healthy enamel were similar to that reported by Silverstone et al.<sup>17</sup> However, they reported type 1 etching pattern as the most common while in our study type 2 was the most common. Etching pattern of defective enamel was vague and has no resemblance to that

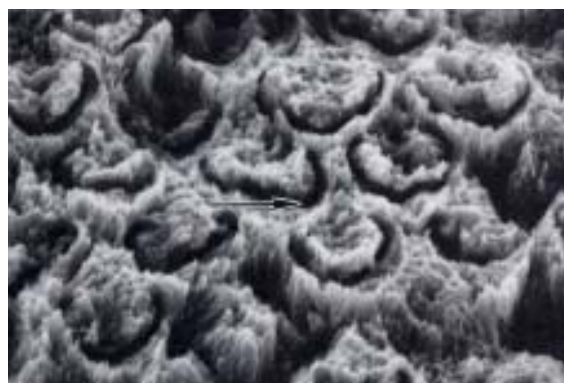
Figure 7. SEM photomicrograph of defective enamel that has been etched for 60 seconds. Note the variations of etching pattern. (x 600)

of normal enamel. This could be due to difference in structure and composition of defective enamel. Poole et al<sup>18</sup> suggested that variation of etching patterns could be due to differences in orientation of crystallites relative to the direction of attack together with differences in chemical composition between central and peripheral parts of enamel prisms. This explanation may highlight the variation in enamel structure that can occur not only between normal and defective enamel but also from tooth to tooth, or site to site, on a single tooth surface. Also, variation of etching patterns for defective enamel could be a result of different etiology of the enamel defects in different teeth which is unknown.
